Inspection Report

-0 Bad House Lane
Prescott AZ 86308

Mile High Property Inspections

Date: 7/25/2019	Time: 08:30 AM	Report ID:
Property: -0 Bad House Lane Prescott AZ 86308	Customer: Report Sample	Real Estate Professional: Billy Bob Big Bad Realtor Services

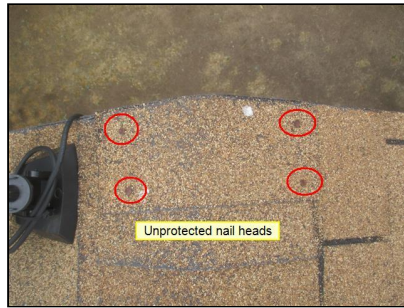
1.0 Item 8

1.0 The roof covering is old, and the life of covering has expired. There are unprotected nail heads present and vent pipe seals that have split. The covering does need to be replaced. It is my understanding that the current owner is replacing the roof and I do suggest replacement and all work by a licensed plumbing contractor.

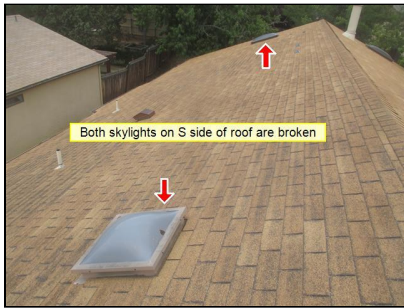
1.2 Item 1

1.2 With exception to vent pipe boots, all roof penetrations appear to be in good condition. There are three skylights on this home and two of them are broken. Suggest replacements by a licensed roofing contractor.

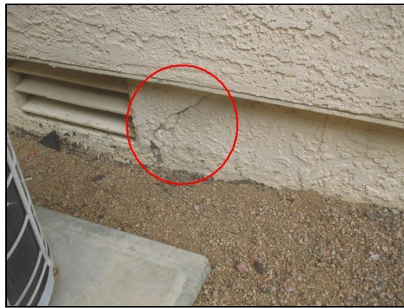
2.0 Item 20

2.0 Exterior wall cladding has many repaired cracks in many areas. This is often very normal with stucco exteriors but this home also does have caulking repairs at all ceiling wall connections of the front entry and back patio. There are large gaps down both sides of the home in the eaves, where the exterior walls meet with the roof or truss system. There are gaps that have been sealed in the entry sidewalk and driveway area. The beam on the back patio has twisted and has at least damaged the stucco at the beam and post connections. I suggest review of the structure by a licensed contractor to determine if there is movement here that effects the home negatively.

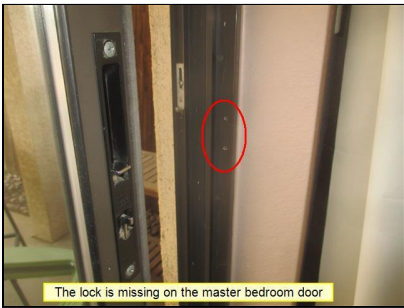
2.1 Item 1

2.1 The front storm door does not open properly. It catches on the latch and often takes several attempts to open it. The lock to the master bedroom glass door is missing. Suggest repairs by a qualified person. The remaining exterior doors operated properly and appeared satisfactory.

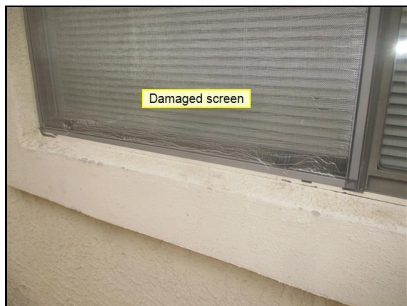
2.2 Item 1

2.2 All windows operated properly, however at least one has a damaged screen and many windows do not have screens installed. There are some screens in the garage. Suggest all screens present be installed and damaged screens be replaced by a qualified contractor.

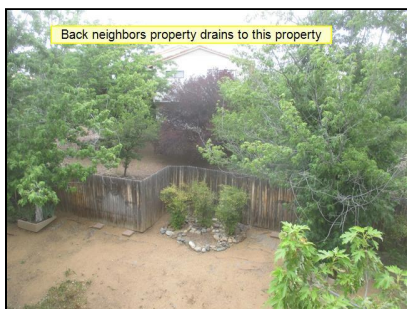
2.4 Item 4

2.4 The driveway and walkway have had movement over time. This is noticeable from gaps and movement or shifts in concrete. Some of this is noted in 2.0 of this section. It is important to be mindful of changes in these areas to avoid any trip hazards. Suggest continued monitoring of all concrete entry areas. The back yard of the home drains all moisture directly to the back patio and left side foundation areas. The water from rain or plants has no way to drain from this property other than into these areas. Part of that is because the back yard is not sloped to drain naturally to and out of the right side of the property. The ground in the back right corner of the home is actually higher and therefore water would have to reach a certain level before it could run off. As an additional note here, the property directly behind the home also drains its rain water down into this property. Suggest evaluation of the back and side yards and creation of proper draining around home by a qualified contractor. The vegetation on the property looks to be in good condition.

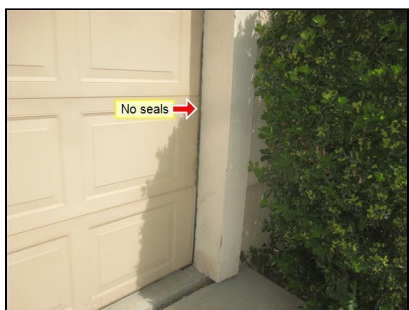
3.3 Item 4

3.3 The garage door is damaged as if a vehicle got up against the door from inside. The garage door appears to have shifted left and there is a gap in the right side of the door. The bottom door seal is damaged and needs to be replaced. The side seals and top seal are missing and there are gaps in these areas. Suggest repairs by a licensed garage door technician.

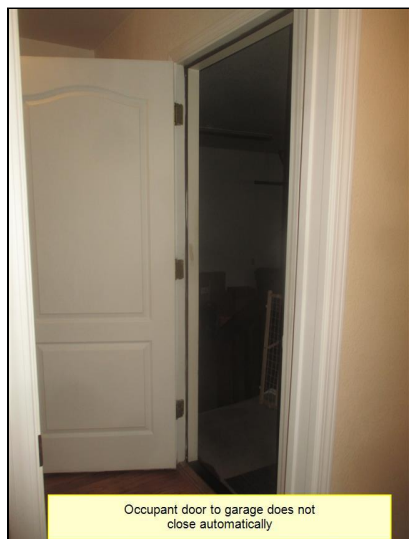
3.4 Item 1

3.4 The occupant door from the garage to the home must have a self closing devise. Self closing hinges are on this door but need to be adjusted or replaced. This door must close completely on its own and must be tight fitting and weather stripped.

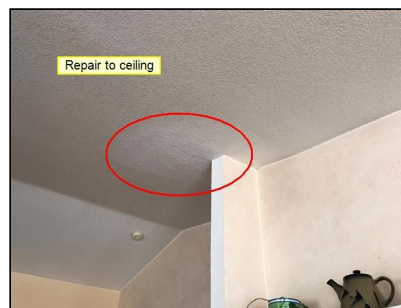
4.0 Item 3

4.0 There are cracks that have been sealed in numerous areas throughout the home. Someone has caulked wall corners, where walls and ceilings come together, throughout many areas of the home. Cracks could be from normal settling or from something like movement in the home as discussed in 2.0 of the Exterior section. Sealing of wall corner areas is highly unusual and I do not wish to speculate why someone would do that. Because of these things, as suggested in 2.0 of the Exterior section, I do also suggest review of the homes interior by a licensed contractor.

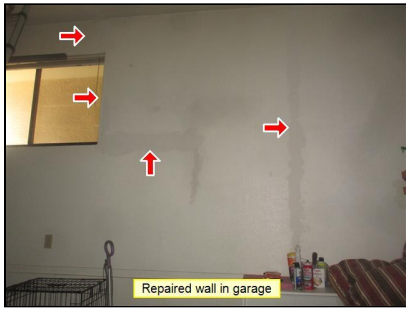
4.1 Item 13

4.1 There are cracks in the walls that have been sealed in numerous areas throughout the home and garage. As mentioned in 4.0 above, someone has also caulked wall corners, where walls and ceilings come together,

throughout many areas of the home. Cracks could be from normal settling or from something like movement in the home as discussed in 2.0 of the Exterior section. Sealing of wall corner areas is highly unusual and I do not wish to speculate why someone would do that. There are repaired areas around the tub and shower areas of the master bathroom and there are poorly repaired wall areas at the guest bathroom. These areas are soft to the touch and these are signs of possible moisture damage that has taken place behind the walls. Because of all these things, as suggested in 4.0 above, I do suggest review of the homes interior by a licensed contractor.

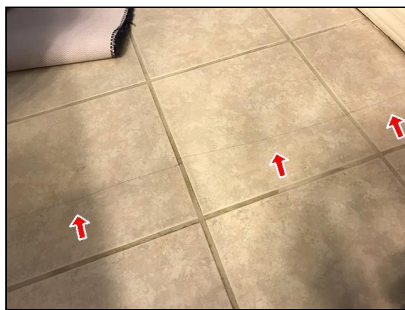
4.2 Item 5

4.2 All floors appear to be in good condition, however after putting a level in several areas, it is obvious that the floor between the kitchen and the entrance hall are completely uneven. The air bubble in the level shows how far the floor is off level. There is a broken floor tile in the guest bedroom hall that looks like it was damaged when installed and there are five broken tiles in the guest bathroom floor. Suggest review of the hump in the floor by a licensed contractor and suggest replacement of broken tiles by a qualified contractor.

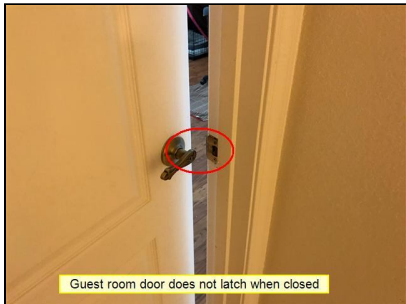
4.4 Item 1

4.4 The guest room door does not latch when closed. All other interior doors operated properly and appear satisfactory.

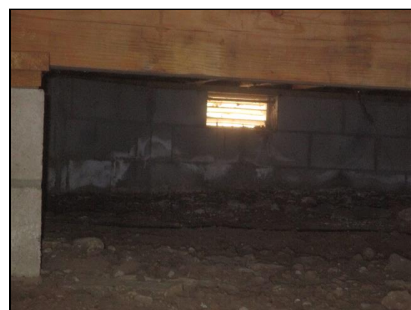
5.0 Item 4

5.0 There appears to have been movement in the soil under the home and it appears that that may have translated into movement at some pier locations. There are signs of moisture in the soil although there has been no rain in the area for some time. There is efflorescence on the block stem walls of the home in the crawlspace. This does not necessarily indicate that intrusion will occur. Efflorescence is found on many homes without water intrusion occurring inside the home. But, it should alert you to the possibility that future steps may be needed. Based on that information and the information provided in 2.0 and 2.4 of the Exterior section in this report. I suggest a complete review of the structure and foundation by a licensed foundation specialist.

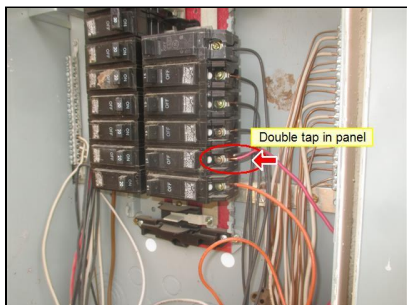
6.1 Item 1

6.1 The overcurrent protection is provided by breakers. The electrical system bonding/grounding appears satisfactory where visible. The main panel and it's components do have a visible deficiency. There is double tapping in the electrical panel. Two or more wires on a single pole breaker can add to the load of the affected circuit causing a possible overload and tripping the breakers. There is a pop out removed from the bottom of the panel and wires have been run through the hole without a proper wire guide. Suggest repairs by a licensed electrical contractor.

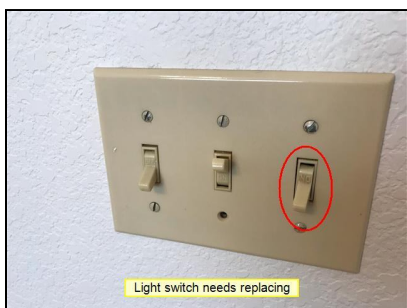
6.3 Item 1

6.3 There are three switches in the guest bedroom. Of the three, the light switch there is installed upside down and appears to be damaged. The light switch for the kitchen is worn out and although it does turn the light on, the switch does not stay firmly in place. Suggest replacement of these switches by a licensed electrical contractor. All other electrical outlets, switches, lights and fans operated satisfactory.

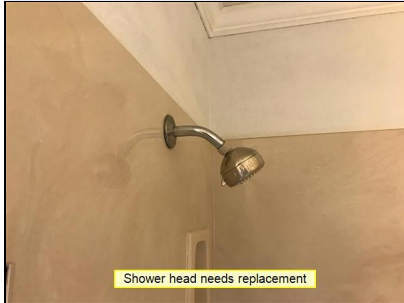
7.1 Item 1

7.1 Water pressure tested at 62 psi. This pressure is considered normal and the system did pass the testing for functional flow. Copper piping appears to exist in the run from the meter to the structure, where visible. (other piping types may exist). The hose bibs are Anti Siphon. The shower head in the master bathroom does not spray well and is in need of replacement. The toilet tank cover in the guest bathroom is broken. The caulking at the guest tub and sink is split and in need of prep and proper caulking. Keeping these areas sealed is important because water from these fixtures can get into these areas if not kept sealed. Suggest repairs by a licensed plumbing contractor. All other fixtures did operate satisfactory.

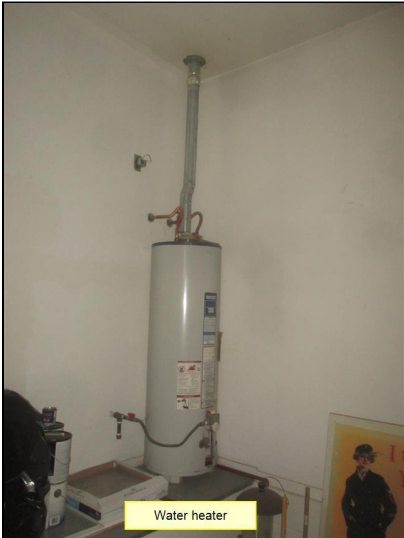
7.2 Item 1

7.2 There is a 40 gallon water heater located in the garage. It is a Bradford White gas unit with Model# M-I-40T5LN-5 and Serial# HB9341277. It was manufactured in Feb. 1991. It delivered hot water during this inspection. The combustion venting on the gas water heater appears satisfactory. The water heater is equipped with a mandated TPR safety valve. Testing this device is not part of the inspection. The piping for the TPR safety valve is required to extend to within six inches of the floor or the ground outside. This piping is about eighteen inches off of the floor. The vent pipe at the top of the unit is not connected properly to a hood. This allows the pipe to be loose and does not exhaust the unit properly to the exterior of the home. These are both safety issues that need to be repaired. Suggest repairs by a licensed plumbing contractor.

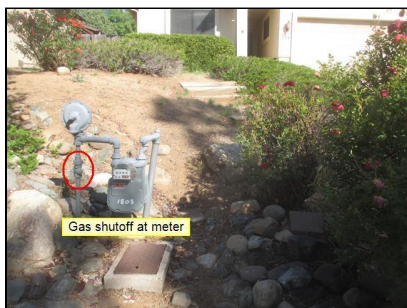
7.5 Item 1

7.5 The main gas shut off is at the gas meter outside in front of the home and there is a gas shutoff at the home behind the bushes.

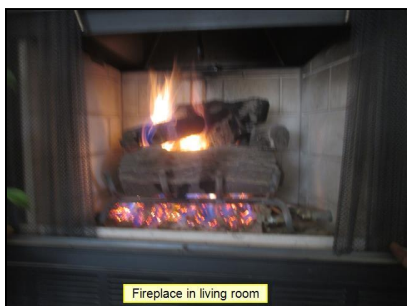
8.6 Item 1

8.6 There is a gas fireplace in this home. It is in the living room. It operated properly with normal operating controls and appeared satisfactory.

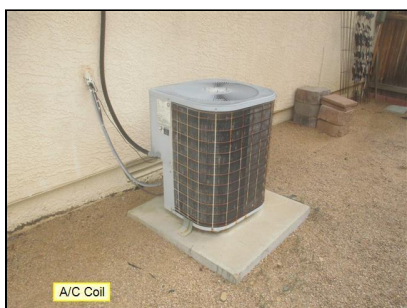
8.7 Item 1

8.7 The A/C condenser coil is located on left side of the home. It is a InterCity unit with Model# CA3036VKB1 and Serial# L912365607. It was manufactured in June 1991 and is a 3 ton unit. The insulation on the suction line is missing. Missing insulation on the suction line can cause energy loss and condensation. Suggest replacement of insulation by a qualified person. This is an old unit, I do suggest review and service but a licensed HVAC contractor and regular service to the unit.

The ambient air test was performed by using thermometers on the air handler of the Heat Pump in cool mode to determine if the difference in temperatures of the supply and return air are between 14 degrees and 22 degrees which indicates that the unit is cooling as intended. The supply air temperature on this system read 55 degrees and the return air temperature was 75 degrees. This indicates the range in temperature drop is normal. This unit performed well and appears satisfactory. The air was cold and the presence of A/C did exist in each room.

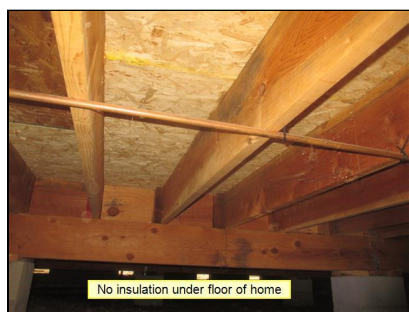
9.1 Item 1

9.1 The floor system is not insulated. Heat loss can occur more on this home than one that is properly insulated. Suggest insulating the floor system by a licensed insulation contractor.

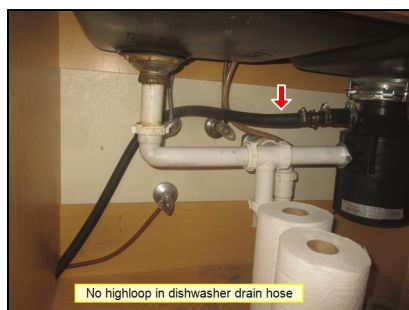
10.0 Item 1

10.0 Dishwasher operated properly through all cycles and appears satisfactory although it is loud. There is no high loop present at dishwasher drain line. This condition could allow debris to backup from sink drain into the dishwasher. It can easily be fixed by a service technician.

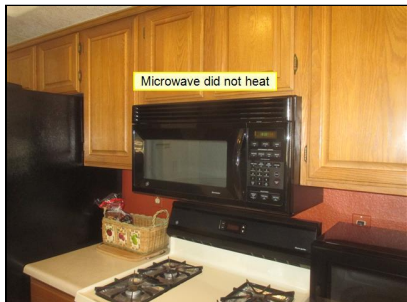
10.4 Item 1

10.4 The microwave operated but did not heat. It is my understanding a new unit is being installed but was not installed at the time of this inspection. .

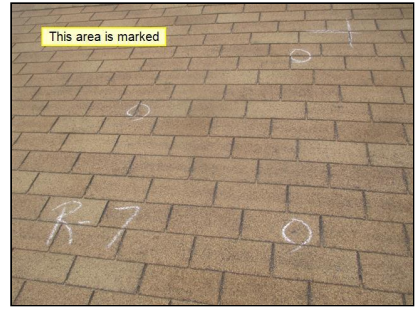
1.0 Item 6

The roof covering is old, and the life of covering has expired. There are unprotected nail heads present and vent pipe seals that have split. The covering does need to be replaced. It is my understanding that the current owner is replacing the roof and I do suggest replacement and all work by a licensed plumbing contractor.

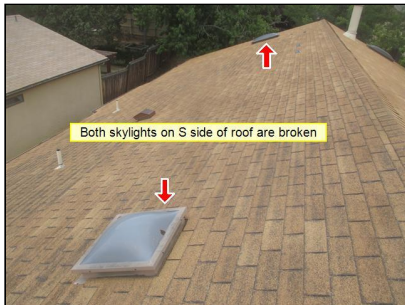
1.2 Item 1

With exception to vent pipe boots, all roof penetrations appear to be in good condition. There are three skylights on this home and two of them are broken. Suggest replacements by a licensed roofing contractor.

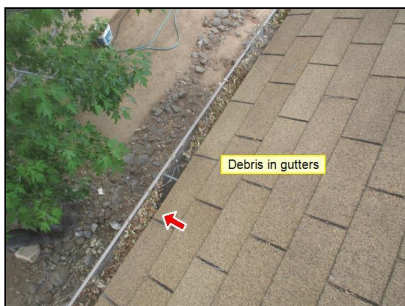
1.3 Item 1

The gutters on the home have a lot of debris in them and the gutter screen covers are warped and also in the gutters.

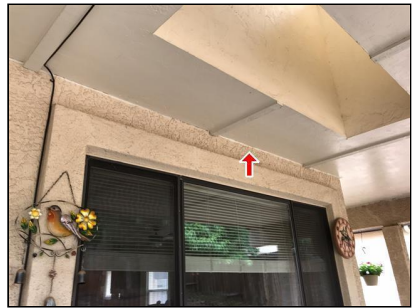
2.0 Item 3

Exterior wall cladding has many repaired cracks in many areas. This is often very normal with stucco exteriors but this home also does have caulking repairs at all ceiling wall connections of the front entry and back patio. There are large gaps down both sides of the home in the eaves, where the exterior walls meet with the roof or truss system. There are gaps that have been sealed in the entry sidewalk and driveway area. The beam on the back patio has twisted and has at least damaged the stucco at the beam and post connections. I suggest review of the structure by a licensed contractor to determine if there is movement here that effects the home negatively.

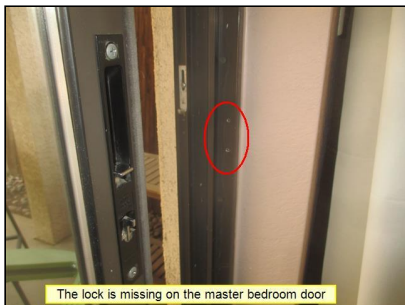
2.1 Item 1

The front storm door does not open properly. It catches on the latch and often takes several attempts to open it. The lock to the master bedroom glass door is missing. Suggest repairs by a qualified person. The remaining exterior doors operated properly and appeared satisfactory.

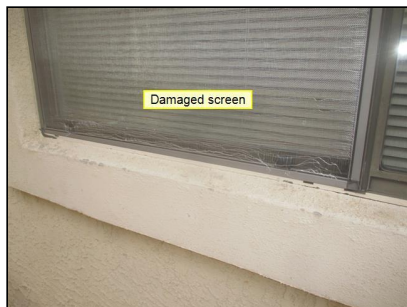
2.2 Item 1

All windows operated properly, however at least one has a damaged screen and many windows do not have screens installed. There are some screens in the garage. Suggest all screens present be installed and damaged screens be replaced by a qualified contractor.

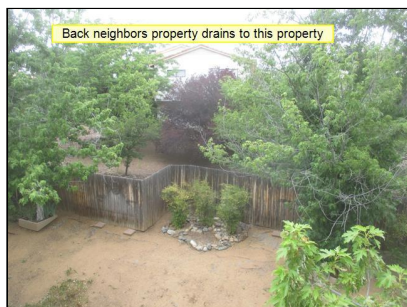
2.4 Item 4

The driveway and walkway have had movement over time. This is noticeable from gaps and movement or shifts in concrete. Some of this is noted in 2.0 of this section. It is important to be mindful of changes in these areas to avoid any trip hazards. Suggest continued monitoring of all concrete entry areas. The back yard of the home drains all moisture directly to the back patio and left side foundation areas. The water from rain or plants has no way to drain from this property other than into these areas. Part of that is because the back yard is not sloped to drain naturally and out of the right side of the property. The ground in the back right corner of the home is actually higher and therefore water would have to reach a certain level before it could run off. As an additional note here, the property directly behind the home also drains its rain water down into this property. Suggest evaluation of the back and side yards and creation of proper draining around home by a qualified contractor. The vegetation on the property looks to be in good condition.

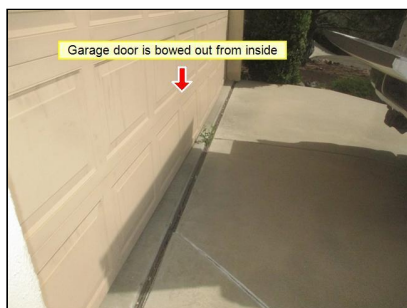
3.3 Item 1

The garage door is damaged as if a vehicle got up against the door from inside. The garage door appears to have shifted left and there is a gap in the right side of the door. The bottom door seal is damaged and needs to be replaced. The side seals and top seal are missing and there are gaps in these areas. Suggest repairs by a licensed garage door technician.

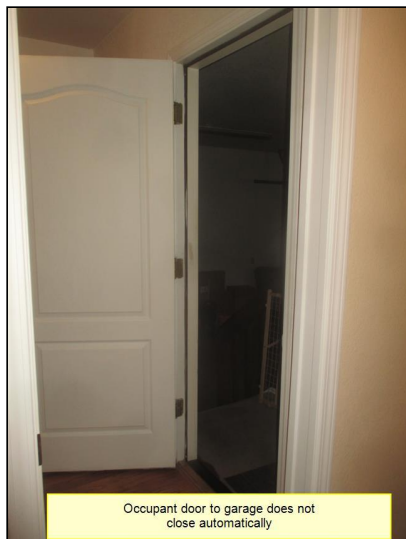
3.4 Item 1

The occupant door from the garage to the home must have a self closing devise. Self closing hinges are on this door but need to be adjusted or replaced. This door must close completely on its own and must be tight fitting and weather stripped.

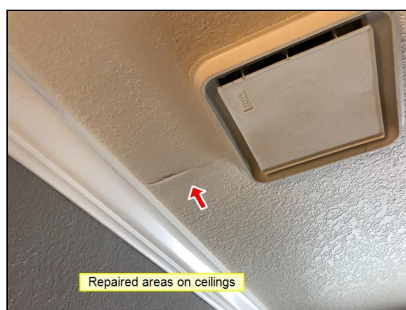
4.0 Item 1

There are cracks that have been sealed in numerous areas throughout the home. Someone has caulked wall corners, where walls and ceilings come together, throughout many areas of the home. Cracks could be from normal settling or from something like movement in the home as discussed in 2.0 of the Exterior section. Sealing of wall corner areas is highly unusual and I do not wish to speculate why someone would do that. Because of these things, as suggested in 2.0 of the Exterior section, I do also suggest review of the homes interior by a licensed contractor.

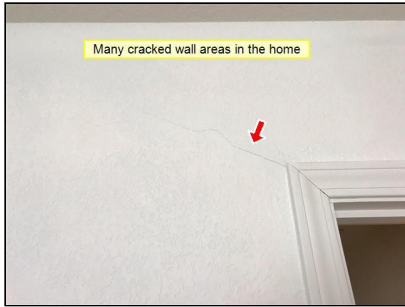
4.1 Item 1

There are cracks in the walls that have been sealed in numerous areas throughout the home and garage. As mentioned in 4.0 above, someone has also caulked wall corners, where walls and ceilings come together, throughout many areas of the home. Cracks could be from normal settling or from something like movement in the home as discussed in 2.0 of the Exterior section. Sealing of wall corner areas is highly unusual and I do not wish to speculate why someone would do that. There are repaired areas around the tub and shower areas of the master bathroom and there are poorly repaired wall areas at the guest bathroom. These areas are soft to the touch and these are signs of possible moisture damage that has taken place behind the walls. Because of all these things, as suggested in 4.0 above, I do suggest review of the homes interior by a licensed contractor.

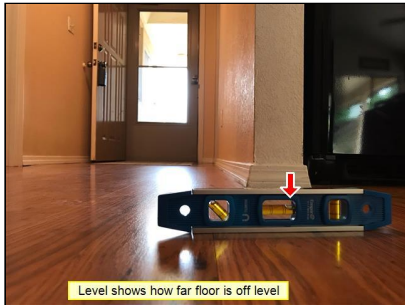
4.2 Item 1

All floors appear to be in good condition, however after putting a level in several areas, it is obvious that the floor between the kitchen and the entrance hall are completely uneven. The air bubble in the level shows how far the floor is off level. There is a broken floor tile in the guest bedroom hall that looks like it was damaged when installed and there are five broken tiles in the guest bathroom floor. Suggest review of the hump in the floor by a licensed contractor and suggest replacement of broken tiles by a qualified contractor.

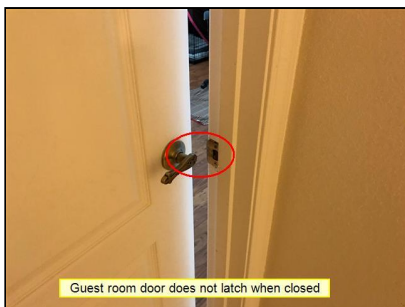
4.4 Item 1

The guest room door does not latch when closed. All other interior doors operated properly and appear satisfactory.

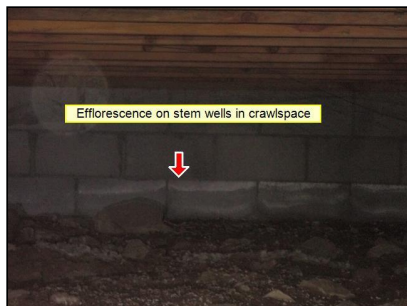
5.0 Item 1

home in the crawlspace. This does not necessarily indicate that intrusion will occur. Efflorescence is found on many homes without water intrusion occurring inside the home. But, it should alert you to the possibility that future steps may be needed. Based on that information and the information provided in 2.0 and 2.4 of the Exterior section in this report. I suggest a complete review of the structure and foundation by a licensed foundation specialist.

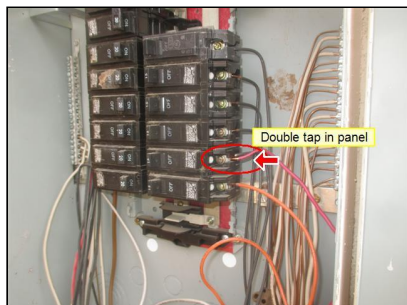
6.1 Item 1

The overcurrent protection is provided by breakers. The electrical system bonding/grounding appears satisfactory where visible. The main panel and it's components do have a visible deficiency. There is double tapping in the electrical panel. Two or more wires on a single pole breaker can add to the load of the affected circuit causing a possible overload and tripping the breakers. There is a pop out removed from the bottom of the panel and wires have been run through the hole without a proper wire guide. Suggest repairs by a licensed electrical contractor.

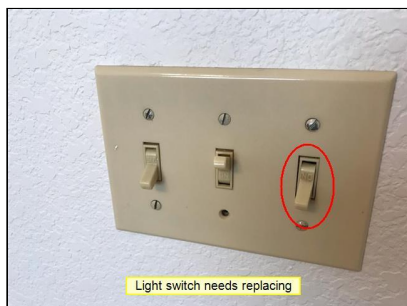
6.3 Item 1

There are three switches in the guest bedroom. Of the three, the light switch there is installed upside down and appears to be damaged. The light switch for the kitchen is worn out and although it does turn the light on, the switch does not stay firmly in place. Suggest replacement of these switches by a licensed electrical contractor. All other electrical outlets, switches, lights and fans operated satisfactory.

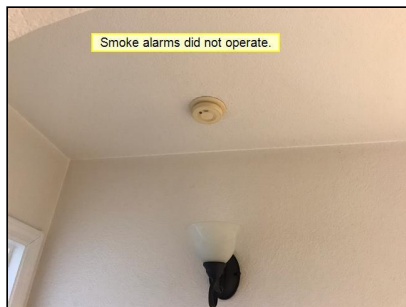
6.7 Item 1

There are two smoke detectors in the home that did not test properly. This home requires at least four smoke detectors. One inside each bedroom and one outside each bedroom. Suggest installation of smoke alarms by a qualified person.

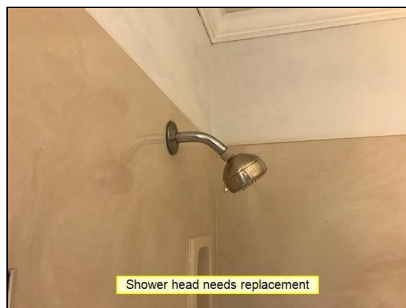
7.1 Item 1

Water pressure tested at 62 psi. This pressure is considered normal and the system did pass the testing for functional flow. Copper piping appears to exist in the run from the meter to the structure, where visible. (other piping types may exist). The hose bibs are Anti Siphon. The shower head in the master bathroom does not spray well and is in need of replacement. The toilet tank cover in the guest bathroom is broken. The caulking at the guest tub and sink is split and in need of prep and proper caulking. Keeping these areas sealed is important because water from these fixtures can get into these areas if not kept sealed. Suggest repairs by a licensed plumbing contractor. All other fixtures did operate satisfactory.

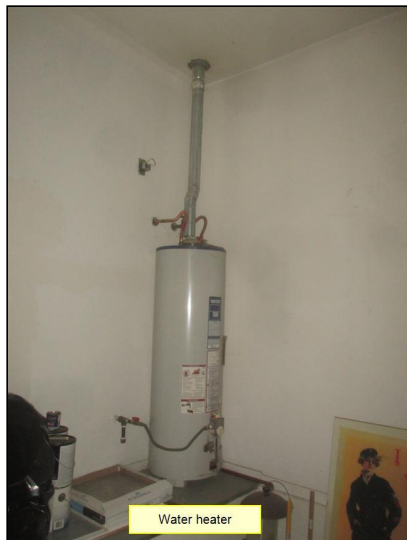
7.2 Item 1

connected properly to a hood. This allows the pipe to be loose and does not exhaust the unit properly to the exterior of the home. These are both safety issues that need to be repaired. Suggest repairs by a licensed plumbing contractor.

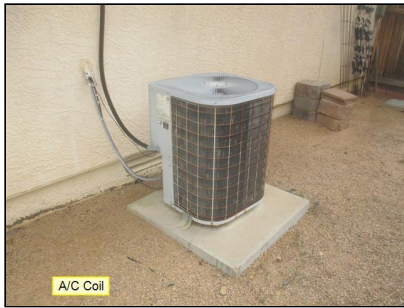
8.7 Item 1

The ambient air test was performed by using thermometers on the air handler of the Heat Pump in cool mode to determine if the difference in temperatures of the supply and return air are between 14 degrees and 22 degrees which indicates that the unit is cooling as intended. The supply air temperature on this system read 55 degrees and the return air temperature was 75 degrees. This indicates the range in temperature drop is normal. This unit performed well and appears satisfactory. The air was cold and the presence of A/C did exist in each room.

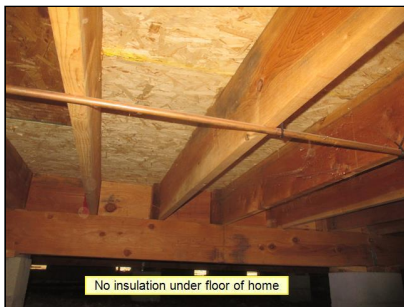
9.1 Item 1

The floor system is not insulated. Heat loss can occur more on this home than one that is properly insulated. Suggest insulating the floor system by a licensed insulation contractor.

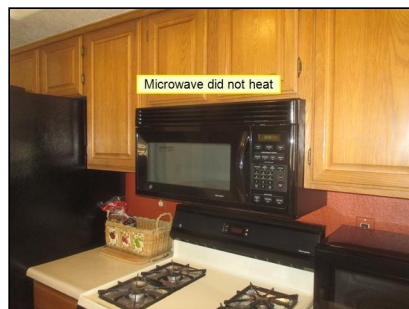
10.4 Item 1

The microwave operated but did not heat. It is my understanding a new unit is being installed but was not installed at the time of this inspection. .
