Inspection Report

-0 Bad House Lane
Prescott AZ 86308

Mile High Property Inspections

Date: 7/25/2019	Time: 08:30 AM	Report ID:
Property: -0 Bad House Lane Prescott AZ 86308	Customer: Report Sample	Real Estate Professional: Billy Bob Big Bad Realtor Services

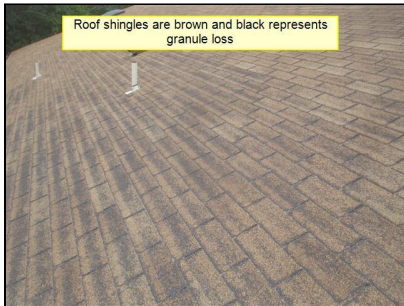
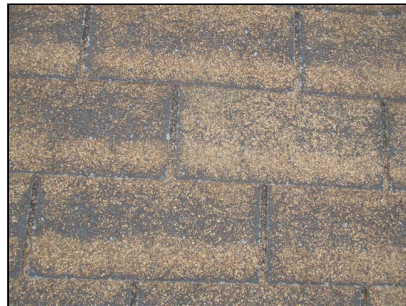
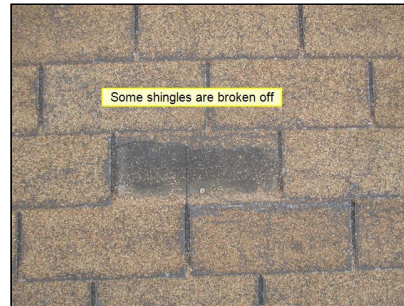
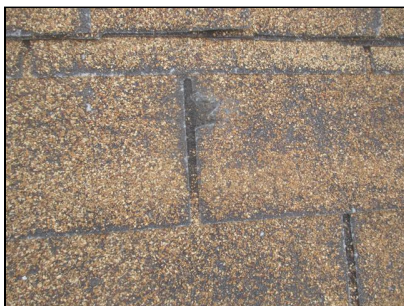
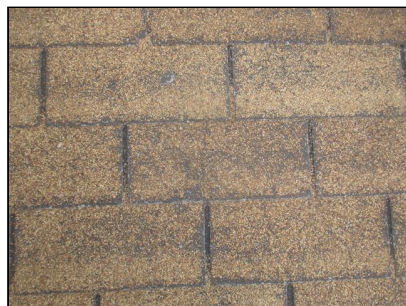
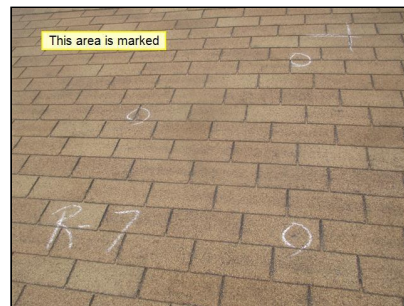
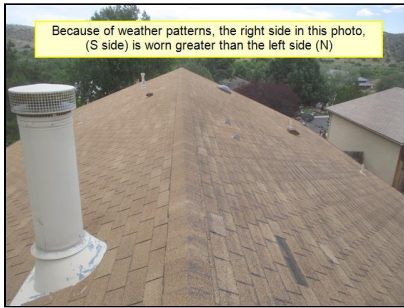
1.0 The roof covering is old, and the life of covering has expired. There are unprotected nail heads present and vent pipe seals that have split. The covering does need to be replaced. It is my understanding that the current owner is replacing the roof and I do suggest replacement and all work by a licensed plumbing contractor.

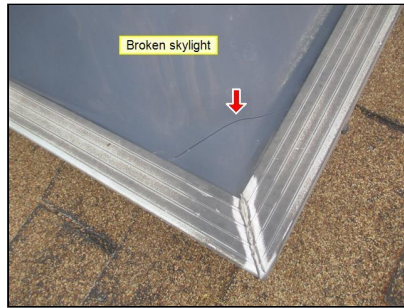
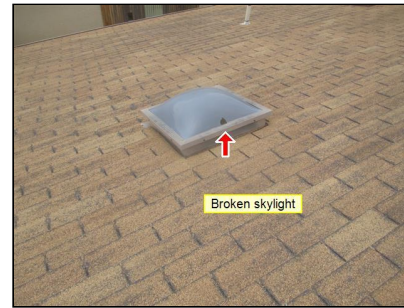
1.2 With exception to vent pipe boots, all roof penetrations appear to be in good condition. There are three skylights on this home and two of them are broken. Suggest replacements by a licensed roofing contractor.

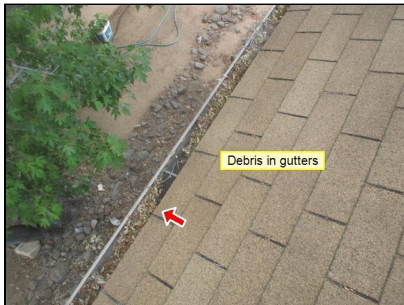
1.3 Item 1

1.3 The gutters on the home have a lot of debris in them and the gutter screen covers are warped and also in the gutters.

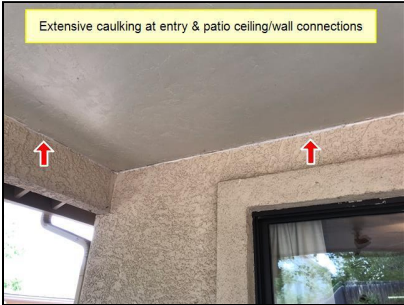
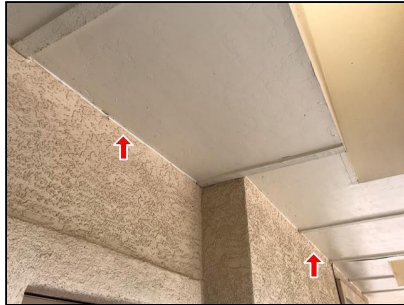
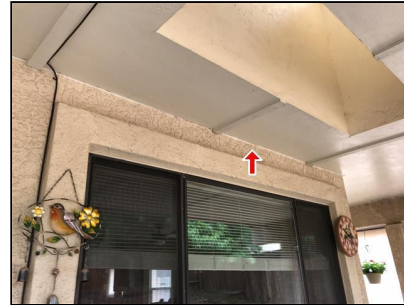
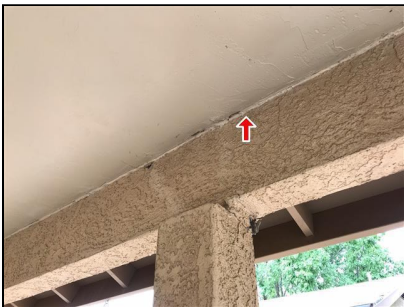
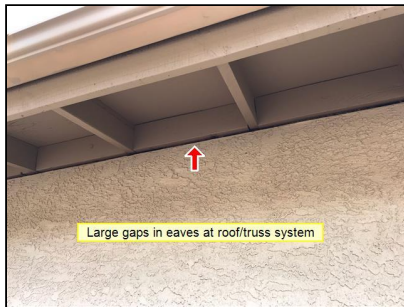
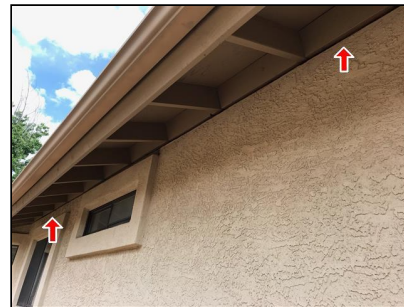
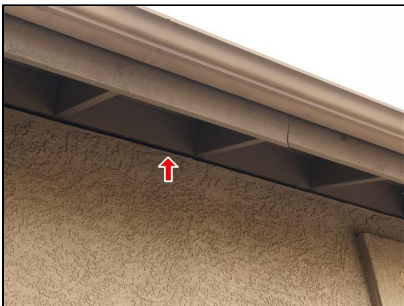
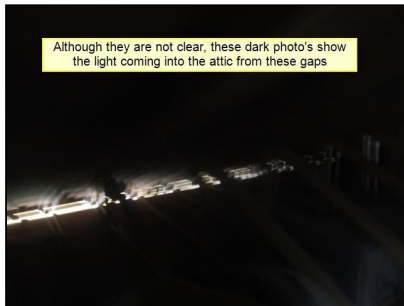
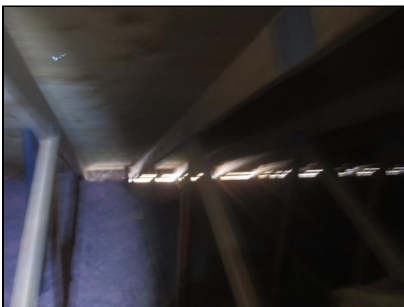
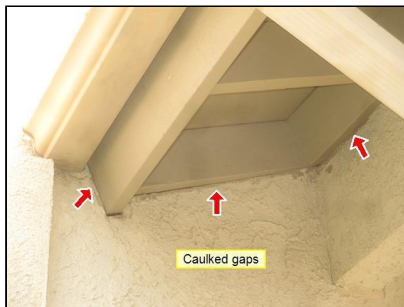
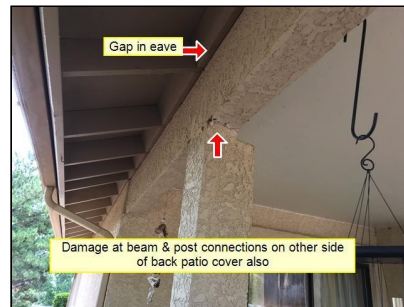
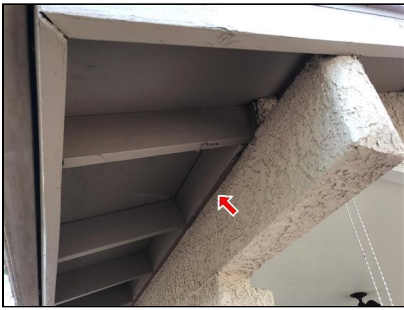
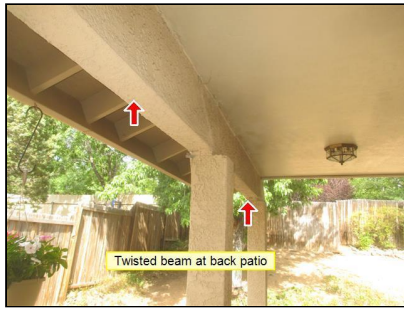
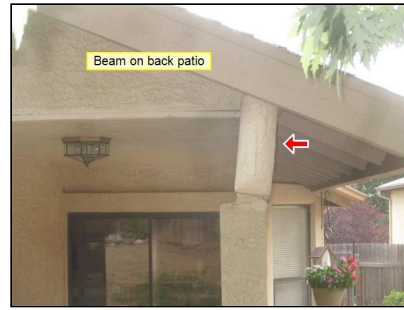
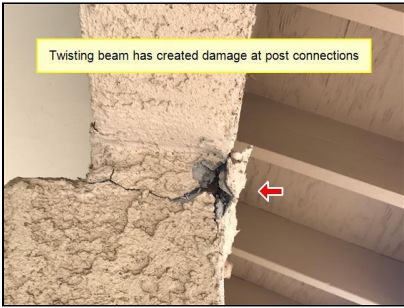
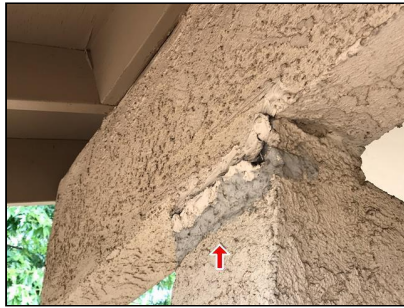
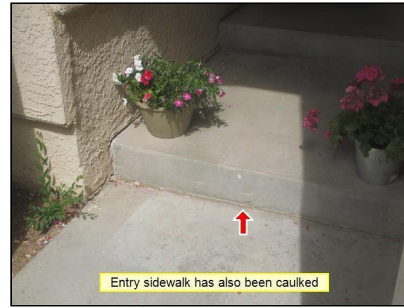
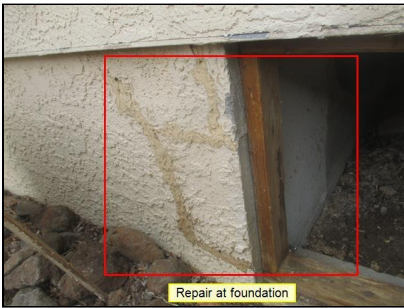
2.0 Exterior wall cladding has many repaired cracks in many areas. This is often very normal with stucco exteriors but this home also does have caulking repairs at all ceiling wall connections of the front entry and back patio. There are large gaps down both sides of the home in the eaves, where the exterior walls meet with the roof or truss system. There are gaps that have been sealed in the entry sidewalk and driveway area. The beam on the back patio has twisted and has at least damaged the stucco at the beam and post connections. I suggest review of the structure by a licensed contractor to determine if there is movement here that effects the home negatively.

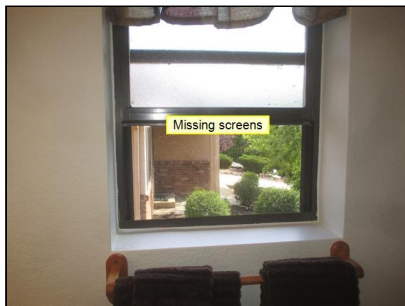
2.2 Item 2

2.2 All windows operated properly, however at least one has a damaged screen and many windows do not have screens installed. There are some screens in the garage. Suggest all screens present be installed and damaged screens be replaced by a qualified contractor.

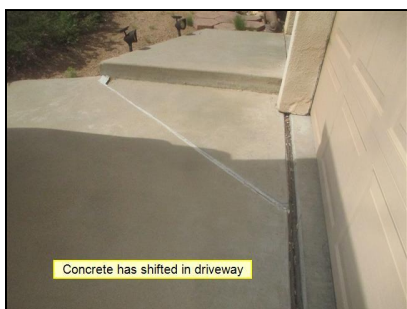
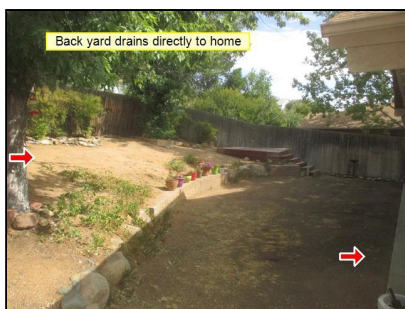
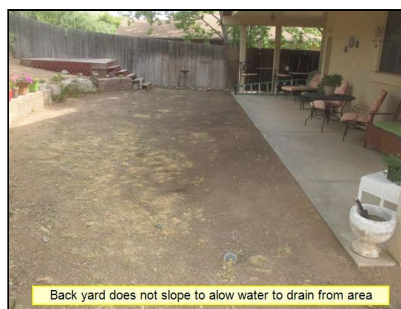
2.4 The driveway and walkway have had movement over time. This is noticeable from gaps and movement or shifts in concrete. Some of this is noted in 2.0 of this section. It is important to be mindful of changes in these areas to avoid any trip hazards. Suggest continued monitoring of all concrete entry areas. The back yard of the home drains all moisture directly to the back patio and left side foundation areas. The water from rain or plants has no way to drain from this property other than into these areas. Part of that is because the back yard is not sloped to drain naturally to and out of the right side of the property. The ground in the back right corner of the home is actually higher and therefore water would have to reach a certain level before it could run off. As an additional note here, the property directly behind the home also drains its rain water down into this property. Suggest evaluation of the back and side yards and creation of proper draining around home by a qualified contractor. The vegetation on the property looks to be in good condition.

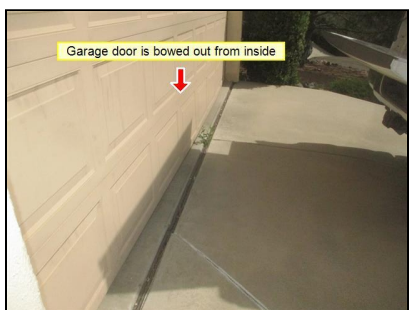
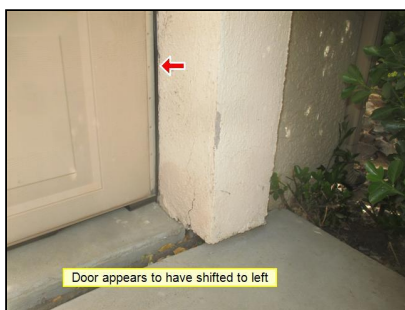
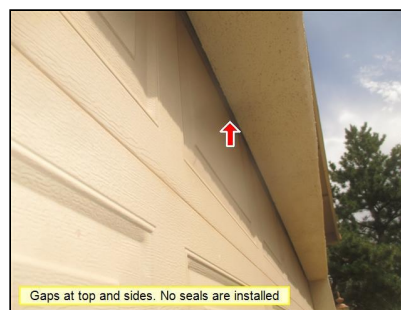
3.3 The garage door is damaged as if a vehicle got up against the door from inside. The garage door appears to have shifted left and there is a gap in the right side of the door. The bottom door seal is damaged and needs to be replaced. The side seals and top seal are missing and there are gaps in these areas. Suggest repairs by a licensed garage door technician.

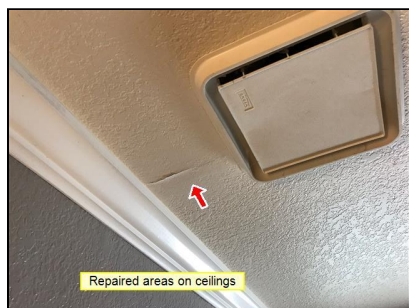
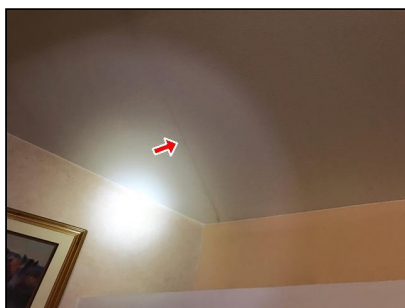
4.0 There are cracks that have been sealed in numerous areas throughout the home. Someone has caulked wall corners, where walls and ceilings come together, throughout many areas of the home. Cracks could be from normal settling or from something like movement in the home as discussed in 2.0 of the Exterior section. Sealing of wall corner areas is highly unusual and I do not wish to speculate why someone would do that. Because of these things, as suggested in 2.0 of the Exterior section, I do also suggest review of the homes interior by a licensed contractor.

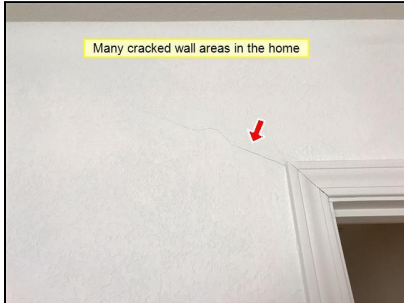
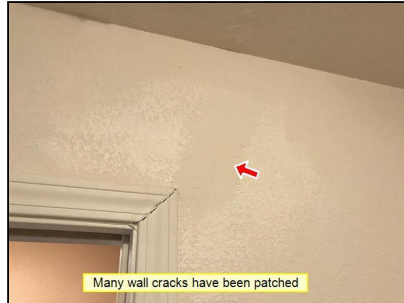
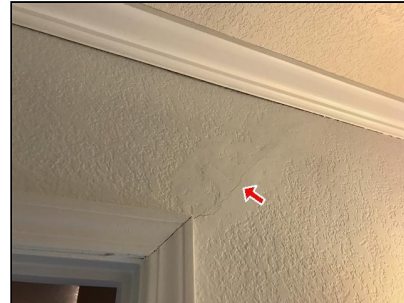
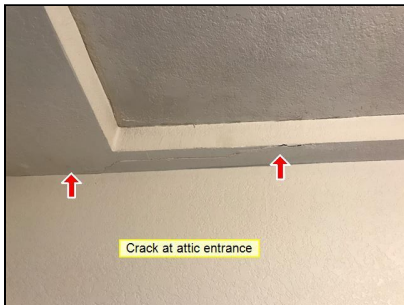
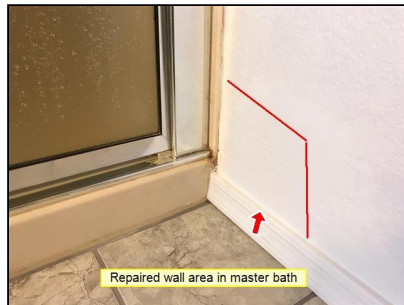
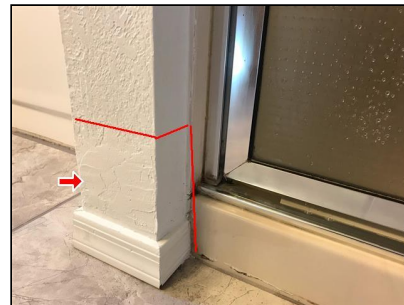
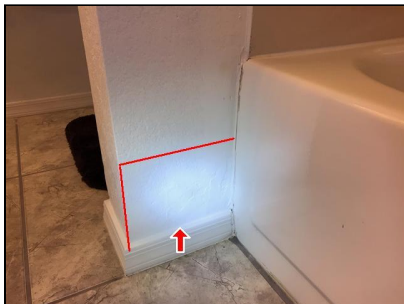
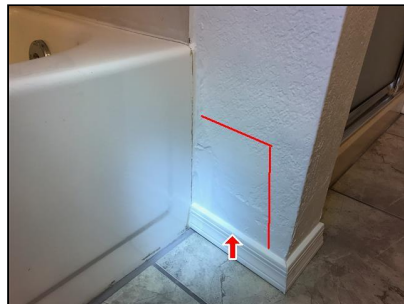
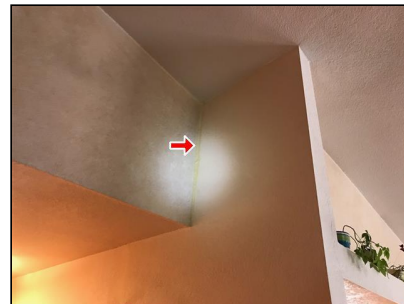
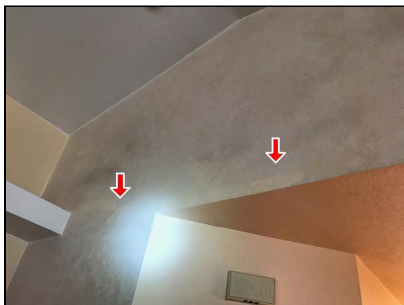
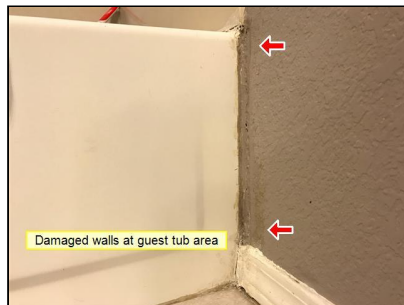
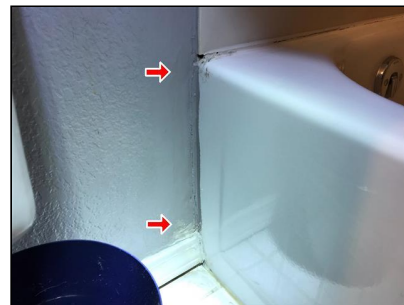
4.1 There are cracks in the walls that have been sealed in numerous areas throughout the home and garage. As mentioned in 4.0 above, someone has also caulked wall corners, where walls and ceilings come together,

throughout many areas of the home. Cracks could be from normal settling or from something like movement in the home as discussed in 2.0 of the Exterior section. Sealing of wall corner areas is highly unusual and I do not wish to speculate why someone would do that. There are repaired areas around the tub and shower areas of the master bathroom and there are poorly repaired wall areas at the guest bathroom. These areas are soft to the touch and these are signs of possible moisture damage that has taken place behind the walls. Because of all these things, as suggested in 4.0 above, I do suggest review of the homes interior by a licensed contractor.

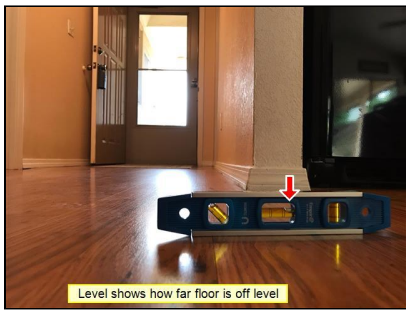
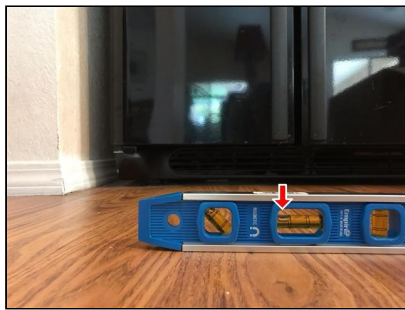
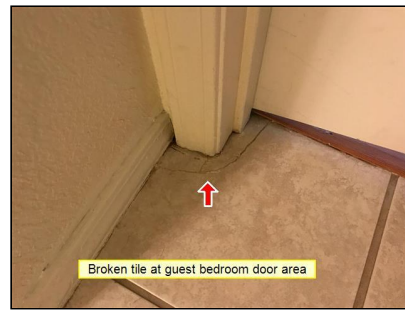
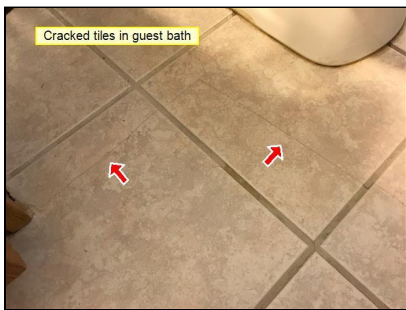
4.2 All floors appear to be in good condition, however after putting a level in several areas, it is obvious that the floor between the kitchen and the entrance hall are completely uneven. The air bubble in the level shows how far the floor is off level. There is a broken floor tile in the guest bedroom hall that looks like it was damaged when installed and there are five broken tiles in the guest bathroom floor. Suggest review of the hump in the floor by a licensed contractor and suggest replacement of broken tiles by a qualified contractor.

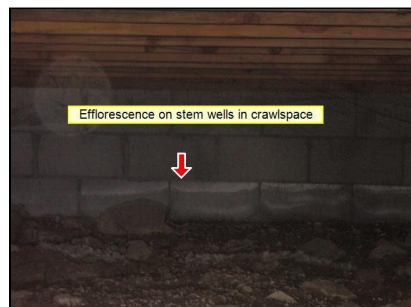
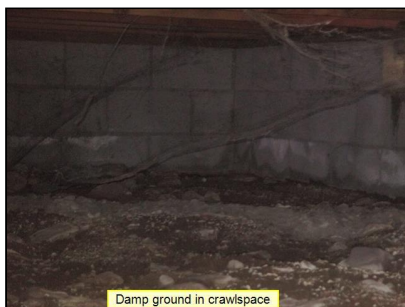
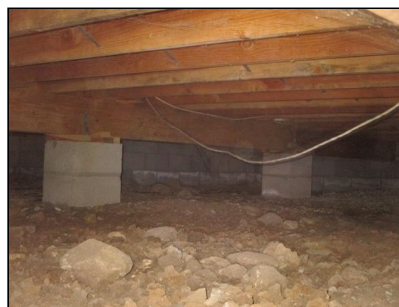
5.0 There appears to have been movement in the soil under the home and it appears that that may have translated into movement at some pier locations. There are signs of moisture in the soil although there has been no rain in the area for some time. There is efflorescence on the block stem walls of the home in the crawlspace. This does not necessarily indicate that intrusion will occur. Efflorescence is found on many homes without water intrusion occurring inside the home. But, it should alert you to the possibility that future steps may be needed. Based on that information and the information provided in 2.0 and 2.4 of the Exterior section in this report. I suggest a complete review of the structure and foundation by a licensed foundation specialist.

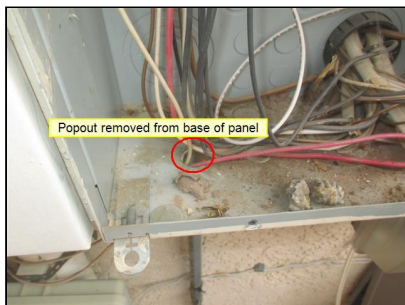
6.1 Item 2

6.1 The overcurrent protection is provided by breakers. The electrical system bonding/grounding appears satisfactory where visible. The main panel and it's components do have a visible deficiency. There is double tapping in the electrical panel. Two or more wires on a single pole breaker can add to the load of the affected circuit causing a possible overload and tripping the breakers. There is a pop out removed from the bottom of the panel and wires have been run through the hole without a proper wire guide. Suggest repairs by a licensed electrical contractor.

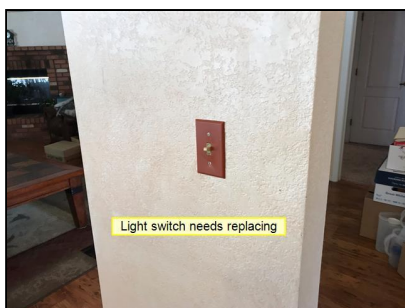
6.3 Item 2

6.3 There are three switches in the guest bedroom. Of the three, the light switch there is installed upside down and appears to be damaged. The light switch for the kitchen is worn out and although it does turn the light on, the switch does not stay firmly in place. Suggest replacement of these switches by a licensed electrical contractor. All other electrical outlets, switches, lights and fans operated satisfactory.

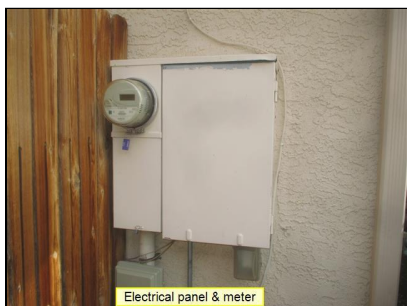
6.6 Item 1

6.6 The electrical panel is located outside on the left exterior wall with the electrical meter.

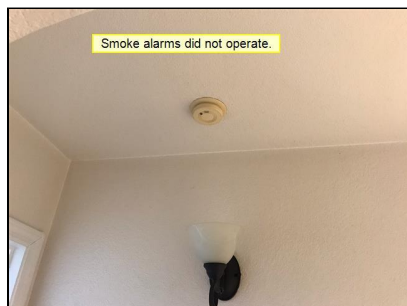
6.7 Item 1

6.7 There are two smoke detectors in the home that did not test properly. This home requires at least four smoke detectors. One inside each bedroom and one outside each bedroom. Suggest installation of smoke alarms by a qualified person.

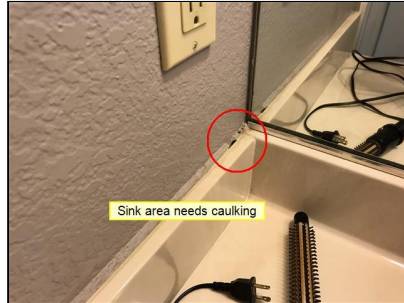
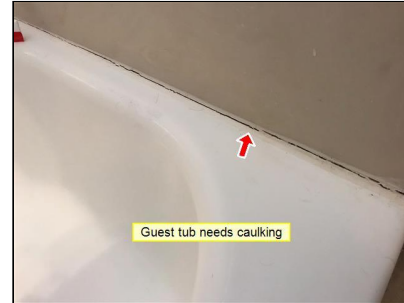
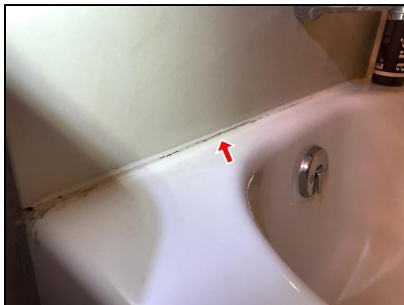
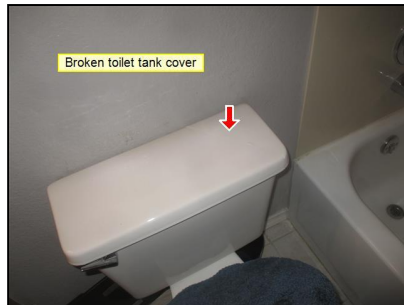
7.1 Water pressure tested at 62 psi. This pressure is considered normal and the system did pass the testing for functional flow. Copper piping appears to exist in the run from the meter to the structure, where visible. (other piping types may exist). The hose bibs are Anti Siphon. The shower head in the master bathroom does not spray well and is in need of replacement. The toilet tank cover in the guest bathroom is broken. The caulking at the guest tub and sink is split and in need of prep and proper caulking. Keeping these areas sealed is important because water from these fixtures can get into these areas if not kept sealed. Suggest repairs by a licensed plumbing contractor. All other fixtures did operate satisfactory.

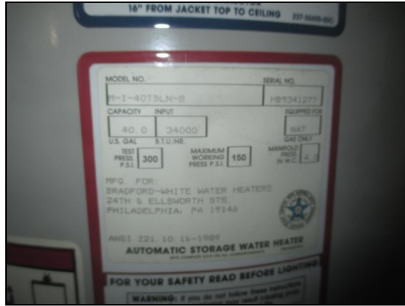
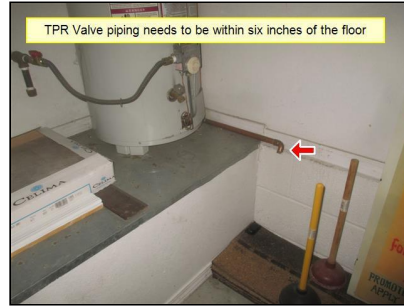
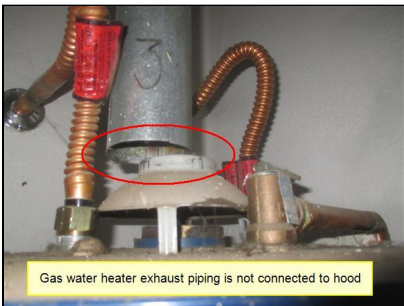
7.2 There is a 40 gallon water heater located in the garage. It is a Bradford White gas unit with Model# M-I-40T5LN-5 and Serial# HB9341277. It was manufactured in Feb. 1991. It delivered hot water during this inspection. The combustion venting on the gas water heater appears satisfactory. The water heater is equipped with a mandated TPR safety valve. Testing this device is not part of the inspection. The piping for the TPR safety valve is required to extend to within six inches of the floor or the ground outside. This piping is about eighteen inches off of the floor. The vent pipe at the top of the unit is not connected properly to a hood. This allows the pipe to be loose and does not exhaust the unit properly to the exterior of the home. These are both safety issues that need to be repaired. Suggest repairs by a licensed plumbing contractor.

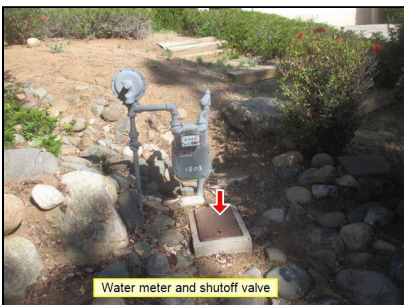
7.3 Item 1

7.3 Main water shut off is to the left of the driveway in the front yard and is in the box with the water meter.

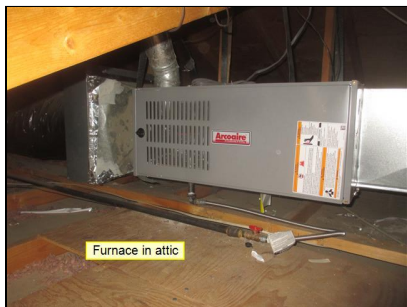
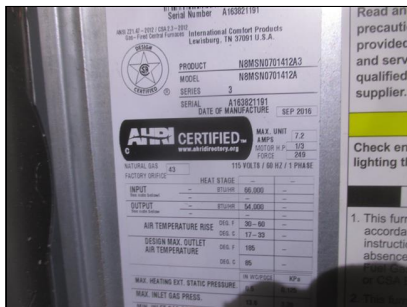
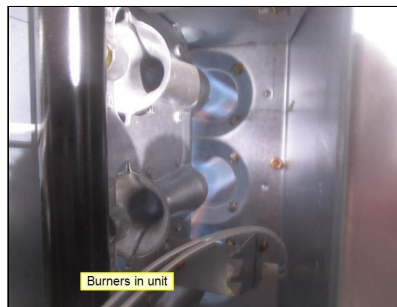
8.0 The gas furnace is in the attic. It is a ArcoAire unit and is 66,000 btu's with Model# N8MSN0701412A and Serial# A163821191. Date of manufacture is Sept. 2016. The gas heating system was operational (function & safety controls) and appears satisfactory. The gas valve and connector appear satisfactory. Automatic safety controls are satisfactory. The combustion air vents for the gas furnace appeared satisfactory.

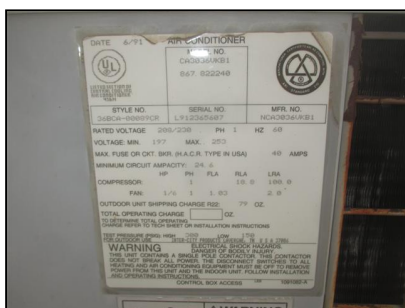
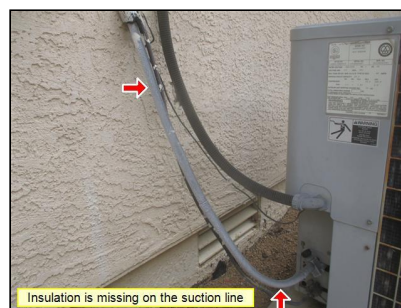
8.7 The A/C condenser coil is located on left side of the home. It is a InterCity unit with Model# CA3036VKB1 and Serial# L912365607. It was manufactured in June 1991 and is a 3 ton unit. The insulation on the suction line is missing. Missing insulation on the suction line can cause energy loss and condensation. Suggest replacement of insulation by a qualified person. This is an old unit, I do suggest review and service but a licensed HVAC contractor and regular service to the unit.

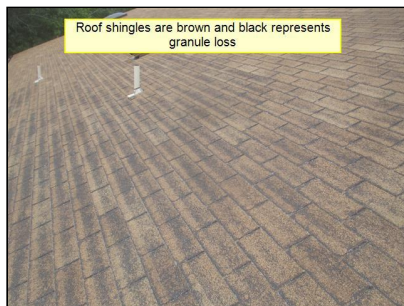
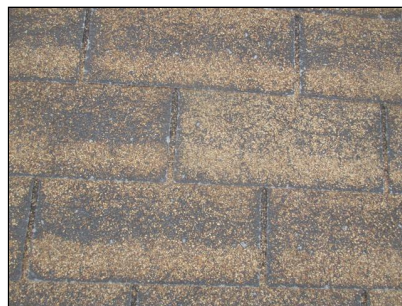
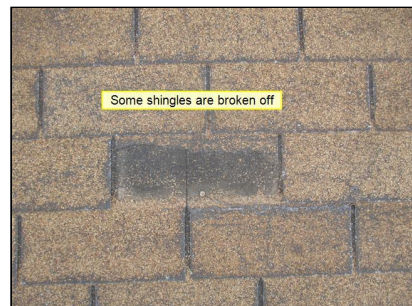
The roof covering is old, and the life of covering has expired. There are unprotected nail heads present and vent pipe seals that have split. The covering does need to be replaced. It is my understanding that the current owner is replacing the roof and I do suggest replacement and all work by a licensed plumbing contractor.

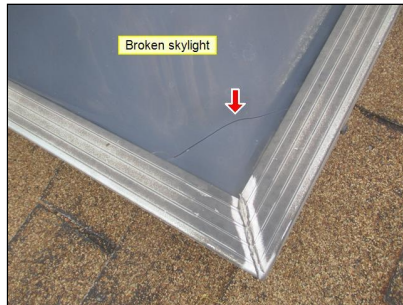
1.2 Item 2

With exception to vent pipe boots, all roof penetrations appear to be in good condition. There are three skylights on this home and two of them are broken. Suggest replacements by a licensed roofing contractor.

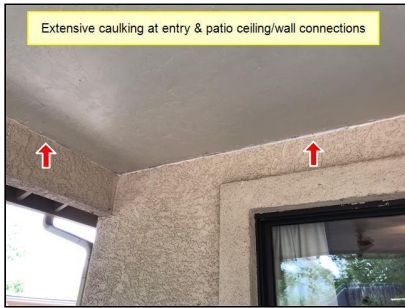
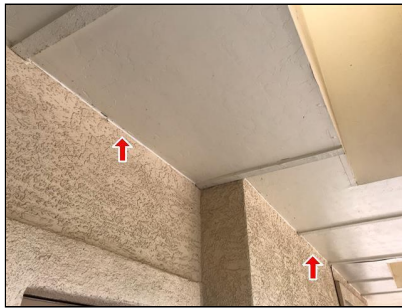
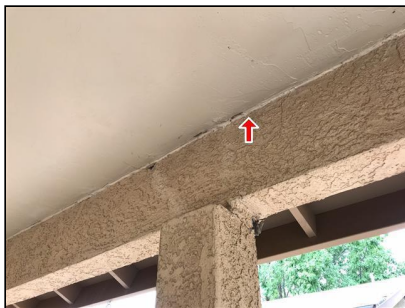
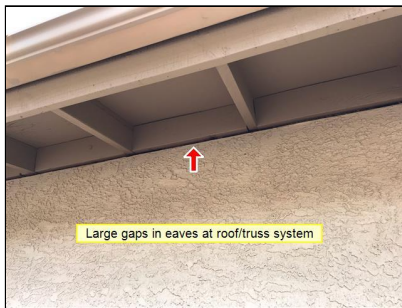
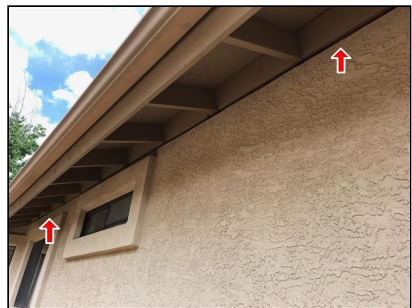
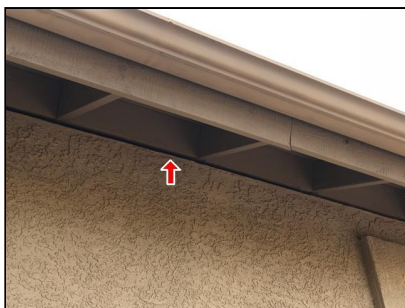
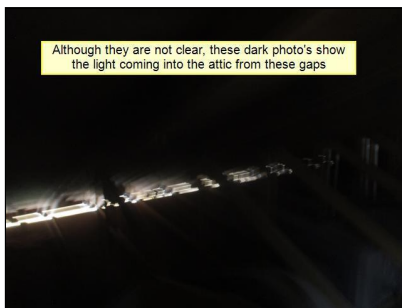
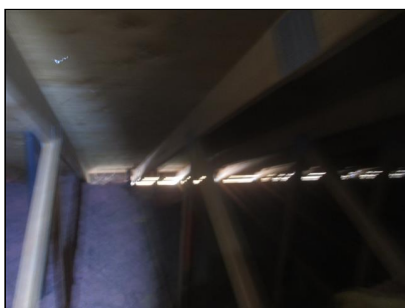
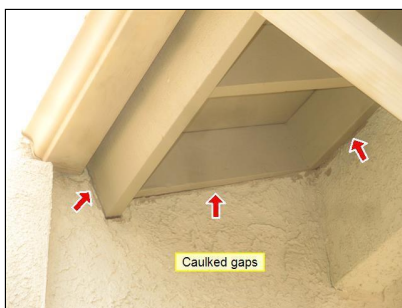
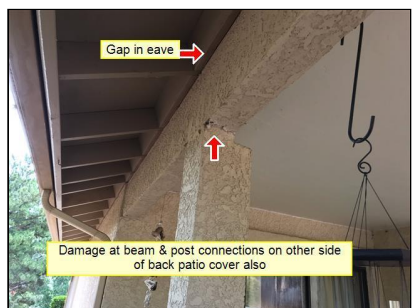
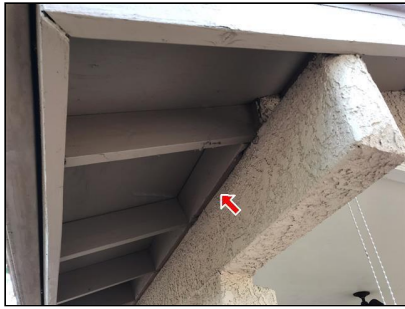
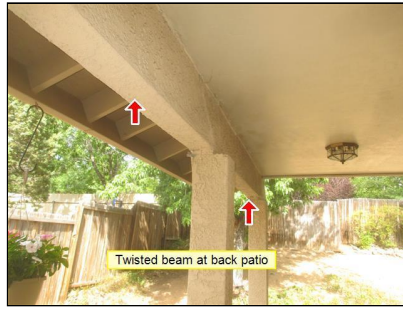
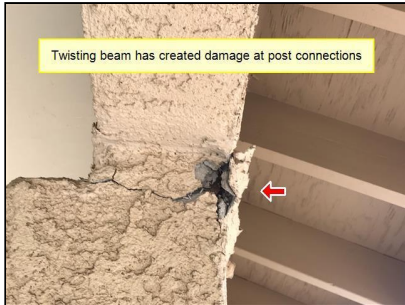
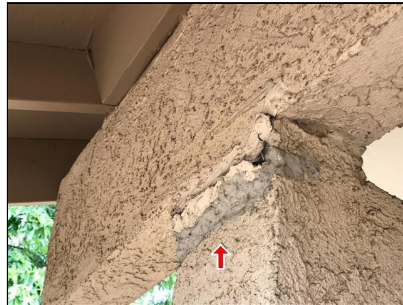
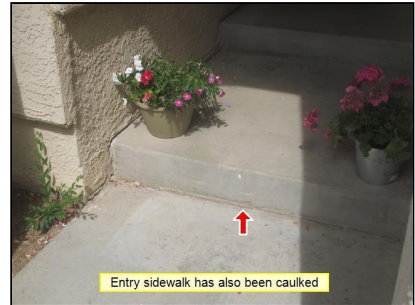
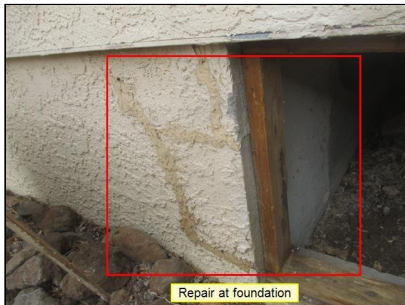
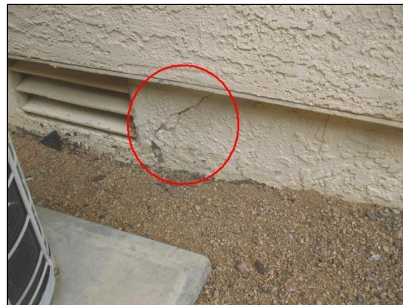
Exterior wall cladding has many repaired cracks in many areas. This is often very normal with stucco exteriors but this home also does have caulking repairs at all ceiling wall connections of the front entry and back patio. There are large gaps down both sides of the home in the eaves, where the exterior walls meet with the roof or truss system. There are gaps that have been sealed in the entry sidewalk and driveway area. The beam on the back patio has twisted and has at least damaged the stucco at the beam and post connections. I suggest review of the structure by a licensed contractor to determine if there is movement here that effects the home negatively.

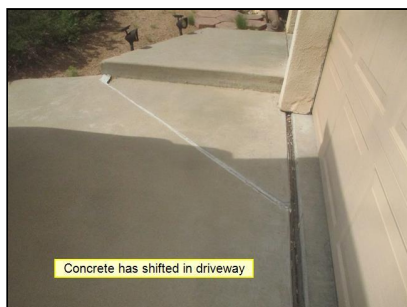
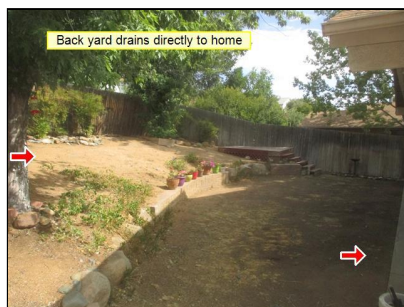
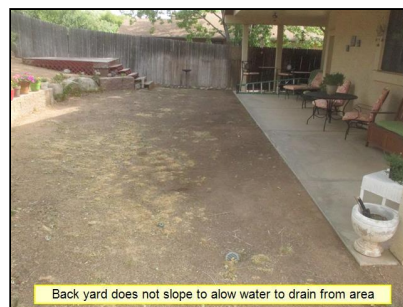
The driveway and walkway have had movement over time. This is noticeable from gaps and movement or shifts in concrete. Some of this is noted in 2.0 of this section. It is important to be mindful of changes in these areas to avoid any trip hazards. Suggest continued monitoring of all concrete entry areas. The back yard of the home drains all moisture directly to the back patio and left side foundation areas. The water from rain or plants has no way to drain from this property other than into these areas. Part of that is because the back yard is not sloped to drain naturally and out of the right side of the property. The ground in the back right corner of the home is actually higher and therefore water would have to reach a certain level before it could run off. As an additional note here, the property directly behind the home also drains its rain water down into this property. Suggest evaluation of the back and side yards and creation of proper draining around home by a qualified contractor. The vegetation on the property looks to be in good condition.

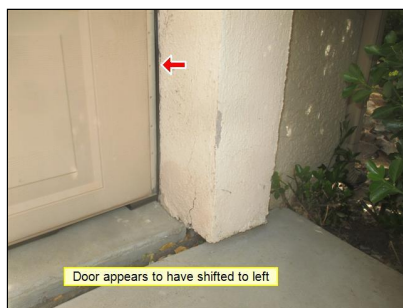
3.3 Item 2

The garage door is damaged as if a vehicle got up against the door from inside. The garage door appears to have shifted left and there is a gap in the right side of the door. The bottom door seal is damaged and needs to be replaced. The side seals and top seal are missing and there are gaps in these areas. Suggest repairs by a licensed garage door technician.

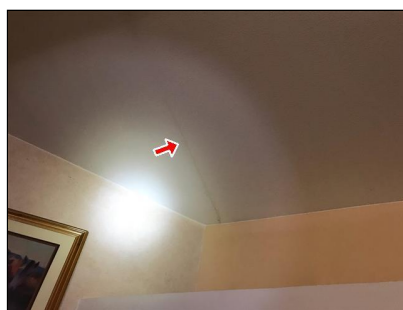
4.0 Item 2

There are cracks that have been sealed in numerous areas throughout the home. Someone has caulked wall corners, where walls and ceilings come together, throughout many areas of the home. Cracks could be from normal settling or from something like movement in the home as discussed in 2.0 of the Exterior section. Sealing of wall corner areas is highly unusual and I do not wish to speculate why someone would do that. Because of these things, as suggested in 2.0 of the Exterior section, I do also suggest review of the homes interior by a licensed contractor.

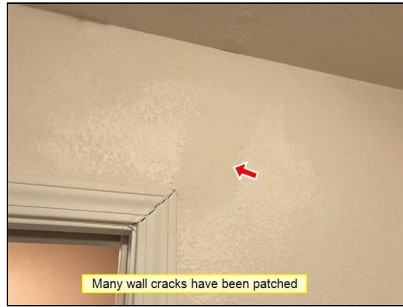
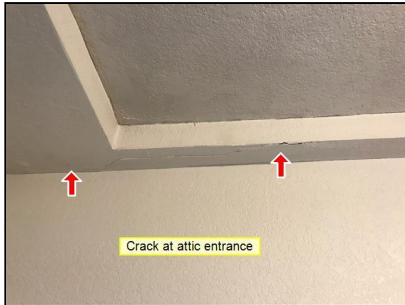
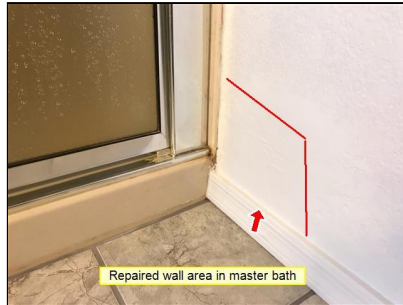
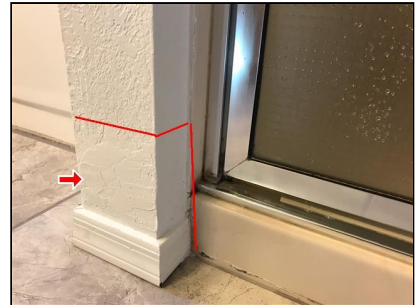
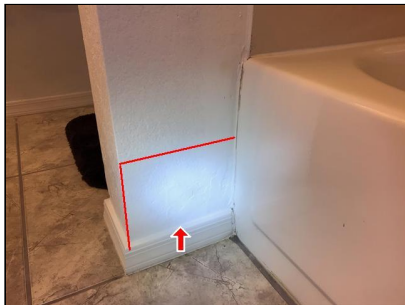
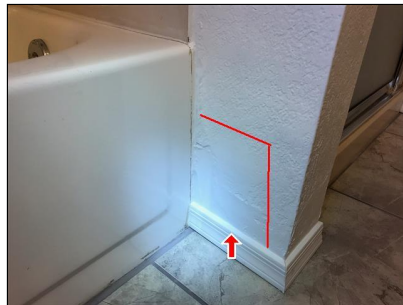
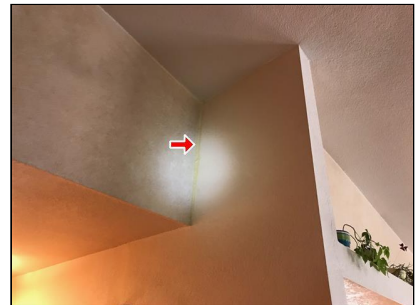
There are cracks in the walls that have been sealed in numerous areas throughout the home and garage. As mentioned in 4.0 above, someone has also caulked wall corners, where walls and ceilings come together, throughout many areas of the home. Cracks could be from normal settling or from something like movement in the home as discussed in 2.0 of the Exterior section. Sealing of wall corner areas is highly unusual and I do not wish to speculate why someone would do that. There are repaired areas around the tub and shower areas of the master bathroom and there are poorly repaired wall areas at the guest bathroom. These areas are soft to the touch and these are signs of possible moisture damage that has taken place behind the walls. Because of all these things, as suggested in 4.0 above, I do suggest review of the homes interior by a licensed contractor.

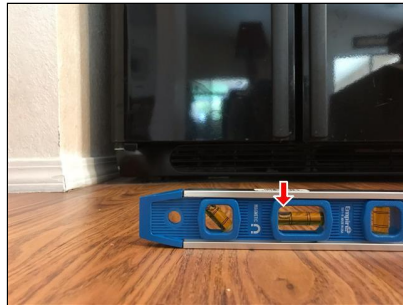
4.2 Item 1

All floors appear to be in good condition, however after putting a level in several areas, it is obvious that the floor between the kitchen and the entrance hall are completely uneven. The air bubble in the level shows how far the floor is off level. There is a broken floor tile in the guest bedroom hall that looks like it was damaged when installed and there are five broken tiles in the guest bathroom floor. Suggest review of the hump in the floor by a licensed contractor and suggest replacement of broken tiles by a qualified contractor.

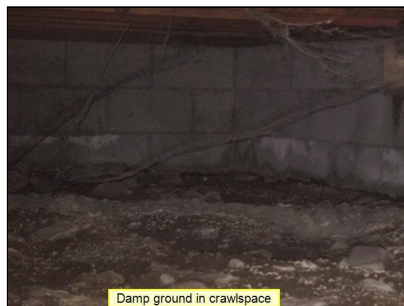
5.0 Item 1

There appears to have been movement in the soil under the home and it appears that that may have translated into movement at some pier locations. There are signs of moisture in the soil although there has been no rain in the area for some time. There is efflorescence on the block stem walls of the

home in the crawlspace. This does not necessarily indicate that intrusion will occur. Efflorescence is found on many homes without water intrusion occurring inside the home. But, it should alert you to the possibility that future steps may be needed. Based on that information and the information provided in 2.0 and 2.4 of the Exterior section in this report. I suggest a complete review of the structure and foundation by a licensed foundation specialist.

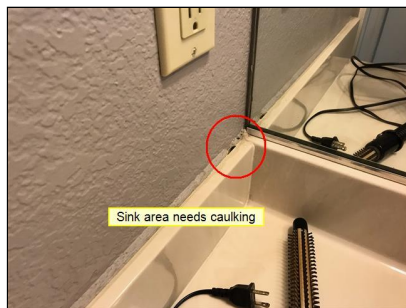
7.1 Item 1

Water pressure tested at 62 psi. This pressure is considered normal and the system did pass the testing for functional flow. Copper piping appears to exist in the run from the meter to the structure, where visible. (other piping types may exist). The hose bibs are Anti Siphon. The shower head in the master bathroom does not spray well and is in need of replacement. The toilet tank cover in the guest bathroom is broken. The caulking at the guest tub and sink is split and in need of prep and proper caulking. Keeping these areas sealed is important because water from these fixtures can get into these areas if not kept sealed. Suggest repairs by a licensed plumbing contractor. All other fixtures did operate satisfactory.

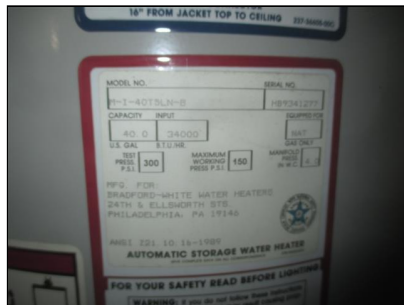
7.2 Item 1

connected properly to a hood. This allows the pipe to be loose and does not exhaust the unit properly to the exterior of the home. These are both safety issues that need to be repaired. Suggest repairs by a licensed plumbing contractor.
